# EVALUATION OF POND WATER TREATMENT SYSTEMS

by  
R. D. Hill  
G. W. Malaney  
G. O. Schwab  
H. H. Weiser

OHIO AGRICULTURAL EXPERIMENT STATION  
Wooster, Ohio

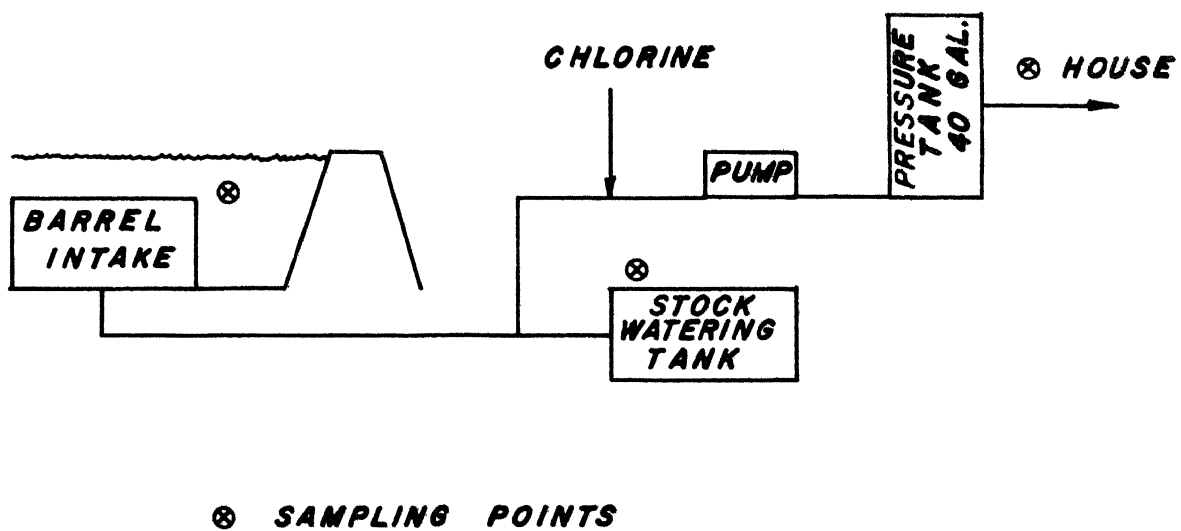
**FIGURE 3. FLOW DIAGRAM OF WATER TREATMENT SYSTEM  
INSTALLATION NO. 6**

Two 55-gallon drums, one set on top of the other, were filled with gravel and used as an intake for the water system at installation 6 (Fig. 6). The only other treatment this water received was chlorination with a Sureclor aspirator type chlorinator (see flow diagram Fig. 3.) Shortly after this investigation began, the home owners stopped using the pond water in the house due to its poor quality. Following this, samples were taken from a stock watering tank below the pond. Two samples were obtained with the chlorinator in use and on both occasions the chlorine residual was zero. It was observed at the time that the flow of chlorine was restricted by a precipitate in the chlorinator. The precipitate was a result of the reaction of chlorine and the iron of the solution water, and the hardness of this water. However, even after cleaning a residual was not detected even though the concentration of chlorine being fed was increased to 5120 mg/l (theoretical concentration in treated water 26.6 mg/l). The reason was undoubtedly the high chlorine demand of the water. The water on July 31, 1958, was high in turbidity and color and had some odor. The high chlorine demand was probably due to organic matter in the water as indicated by the high color and odor, derived from algal growths in the pond.

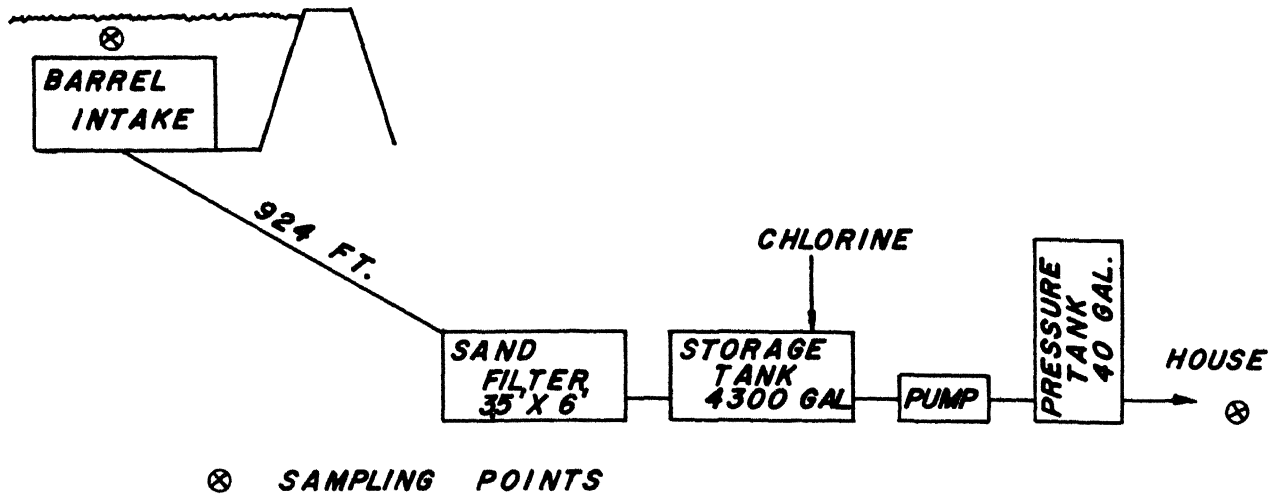
**FIGURE 14. FLOW DIAGRAM OF WATER TREATMENT SYSTEM  
INSTALLATION NO. 26**

The water system at this installation is shown in Fig. 12. The filter depth was not known by the owner, but was estimated to be 4 to 6 feet (Fig. 16). The filter medium was sand and charcoal of unknown quantity. Flow rate could not be determined because of inaccessible pipes. The filter had been installed in 1950 and as of March 1962 had never been cleaned. The water was chlorinated in this storage basin that followed the filter by adding  $\frac{1}{2}$  tablespoon of 24% chlorinated lime or one quart of laundry bleach every two weeks. The amount of chlorine detected in the water varied between 0.0 and 6.0 mg/l with a median of 0.0. Only eleven samples of the twenty-four taken contained a chlorine residual. It appears that the chlorine was lost to the demand of the water and/or was dissipated to the atmosphere in the two week period between additions of chlorine. Also, since water was continuously entering the storage basin, the chlorine content was constantly being diluted throughout the period.

The poor operation of the filter was likely a result of 12 years of no cleaning or maintenance.

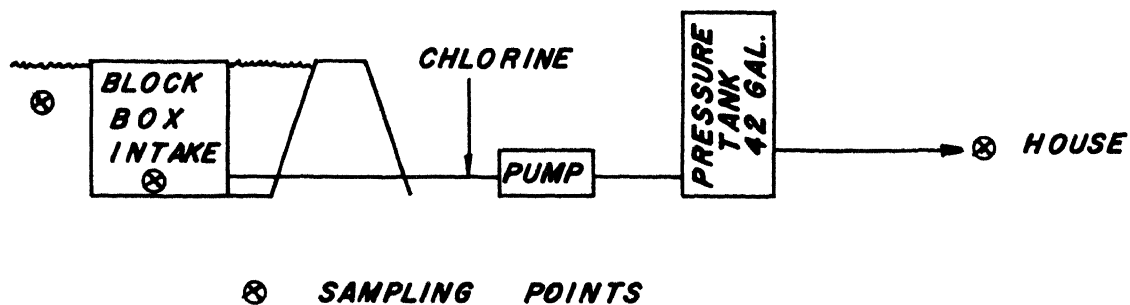
**FIGURE 15. FLOW DIAGRAM OF WATER TREATMENT SYSTEM  
INSTALLATION NO. 62**

The intake at installation 62 was a box 5 feet by 5 feet by 9 feet high, constructed of cinder blocks, extending from the bottom of the pond to a point 2 feet above the surface (when the pond was full) (Fig. 17). There was no filter media in the box. The intake worked on the principal that the pond water would be filtered during passage through the cinder blocks. Water was drawn from the intake by a pump in the basement of the house, where chlorine was added at the pump with a Sureclor injector type chlorinator (Fig. 15).

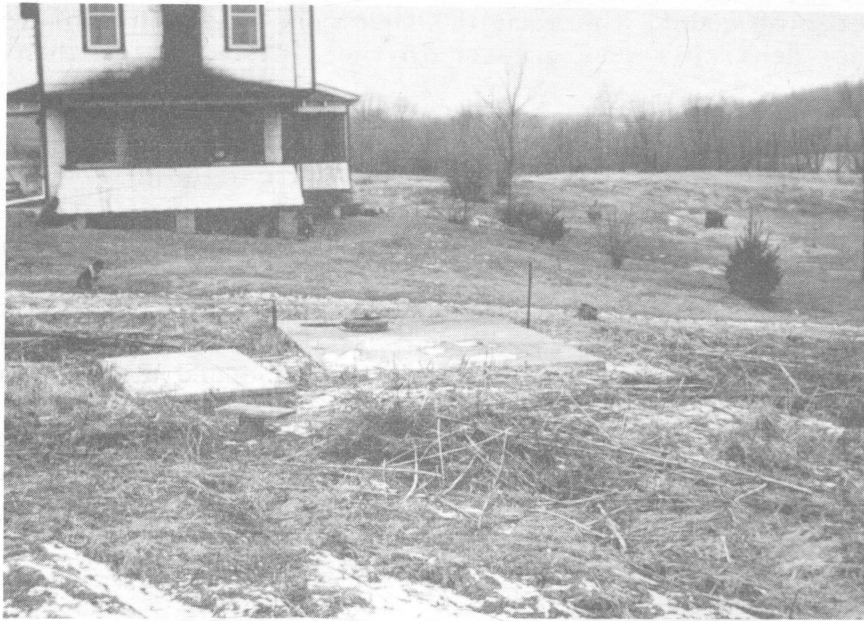
Figure 16. Installation 26. Filter on the left and clear well on the right. Water flowed from the pond to the filter by gravity.

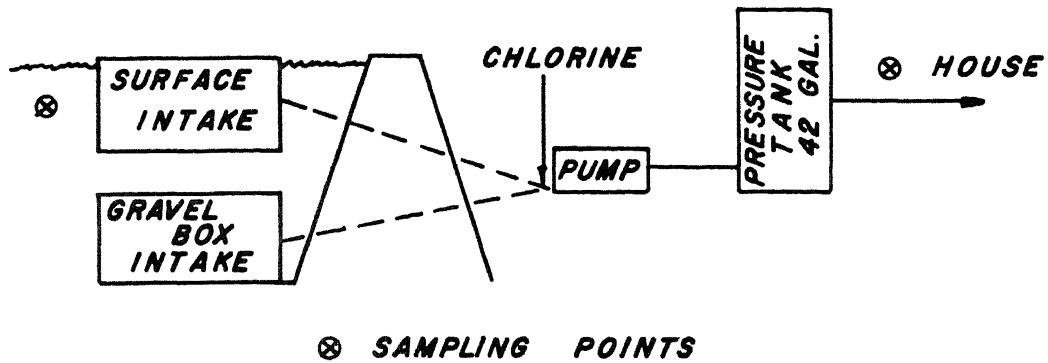
**FIGURE 18. FLOW DIAGRAM OF WATER TREATMENT SYSTEM  
INSTALLATION NO. 86**

A concrete block box 4 feet by 4 feet and 3.5 feet high filled with gravel was used as an intake during the first part of this study. This was later replaced with a surface type intake. Water was drawn through the intake and to the house by a pump located in the basement of the house. A Sureclor chlorinator added chlorine to the water at the pump (Fig. 18). The concrete block box intake was essentially the same as a barrel-type inlet. The intake had little, if any effect, on the turbidity, and color increased upon passage through the intake. On occasions an odor was also present in the water after it had passed through the intake.

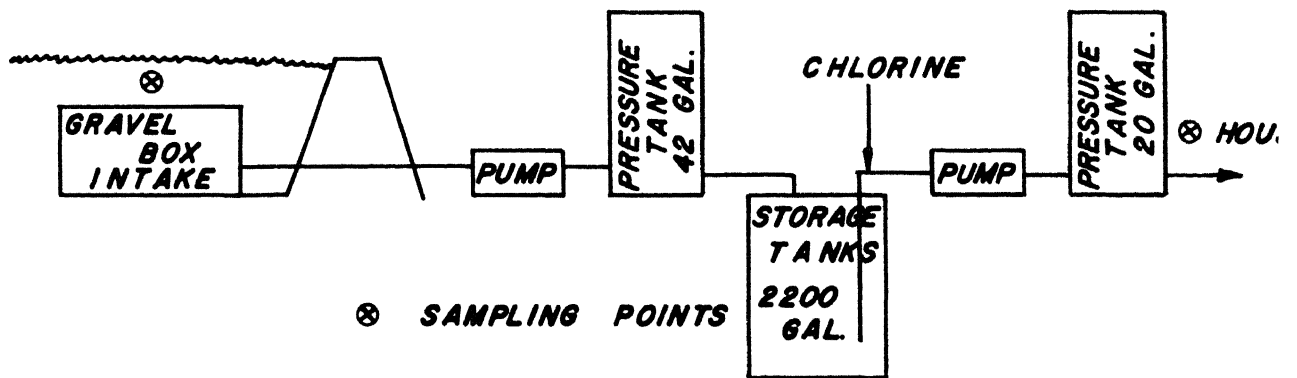
**FIGURE 19. FLOW DIAGRAM OF WATER TREATMENT SYSTEM  
INSTALLATION NO. 87**

Water was pumped from a concrete-gravel-box intake to a barn without further treatment for livestock use and to two cisterns for domestic use. A second pump removed water from the cisterns and supplied the house and milk house. The water was chlorinated at the second pump (Fig. 19).

During the early part of this study when the raw water quality was poor, it appeared that the treatment system did reduce the turbidity and color concentration to some extent, but in most cases not to an acceptable level. As the raw water quality improved, the treated water did likewise, but observed effects of the intake or cistern storage were not as pronounced. In general, results indicate only a minor removal of suspended solids and color when the water quality was poor. The amount of material removed increased as the quality decreased. Satisfactory domestic water was not produced.

Since the water was chlorinated upon removal from the cisterns, the only contact time between chlorine and water was obtained in a 20-gallon pressure tank and in 20 feet of pipe. The calculated contact time was 0.08 minutes. The chlorine residual of the treated water varied from 0.0 to greater than 9.0 mg/l. Fifty percent of 22 samples taken were contaminated with coliform bacteria. Three of the contaminated samples had no chlorine residual while the remaining samples varied in chlorine residual between 0.5 and 5.4 mg/l. At even the highest chlorine residual the Ct factor was only 0.43.

It was observed several times that the chlorine residual varied during a pump cycle. For example, on August 19, 1961, the chlorine residual ranged between a trace and 2 mg/l during one cycle. The chlorinator used at this installation feeds a "slug" of chlorine every few seconds. Unless good mixing occurs this "slug" of chlorine would pass on through the system. Mixing was not sufficient to produce a relatively constant chlorine residual.

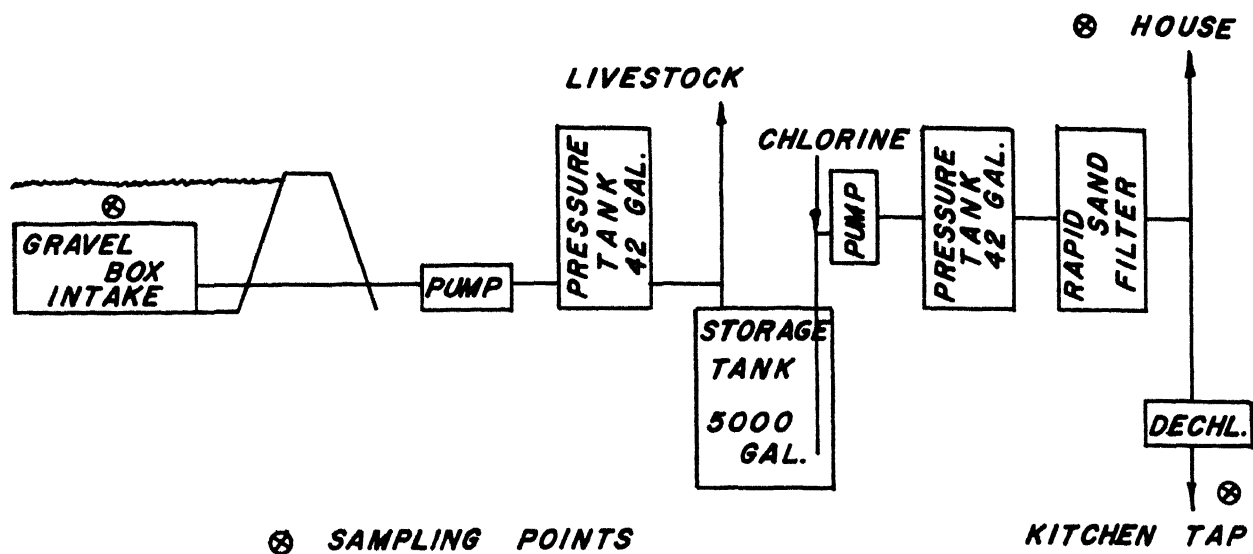
FIGURE 20. FLOW DIAGRAM OF WATER TREATMENT SYSTEM  
INSTALLATION NO. 88

A concrete block box intake filled with sand except for a layer of large stones on top was located on the bottom of the pond. Water was pumped from the intake to an old cistern which was used as a storage tank and settling basin (Fig. 20). Water was then drawn from the cistern, chlorinated and filtered by a pressure sand filter. No further treatment was given to the water other than dechlorination at one cold water tap in the kitchen.

Three samples were examined in 1961 for general bacterial population. The treatment system appeared to reduce the bacterial population but did not completely eliminate it. The low counts in the finished water would not be of significance in the normal usage of water in the home. The enterococci results, when compared to the coliform results, suggest that the enterococci were more resistant to chlorine disinfection than are the coliforms.

The dechlorinator was effective in reducing the turbidity and color to an acceptable concentration (Appendix C). In only one case for both turbidity and color was the Standard not met. In 65% of the samples the chlorine residual was reduced to zero. Only in cases where the influent chlorine was greater than 3.0 mg/l, and not even in all of these cases, was there a residual in the effluent. On seven occasions, the effluent contained coliform bacteria. In three of these the influent also contained coliforms. The remaining four samples must have been contaminated in the dechlorinator, even though they contained between 1.0 and 5.0 mg/l of chlorine when they entered the filter. The only explanation seems to be that at certain times coliform bacteria become established in the filter, probably the interior, where they are protected from destruction because the chlorine was removed at the exterior of the carbon layer.

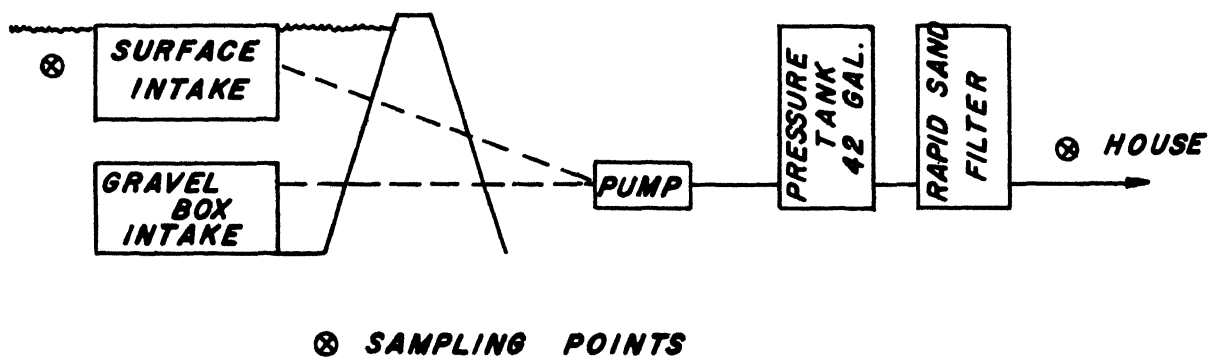
FIGURE 21. FLOW DIAGRAM OF WATER TREATMENT SYSTEM  
INSTALLATION NO. 89

A gravel box intake was being used at installation 89 when this study began. This was later replaced by a surface type intake. Water was drawn from the intake by a pump in the basement of the house and then pumped through a pressure rapid sand filter (Fig. 21). This water was used for all purposes in the house except cooking and drinking.

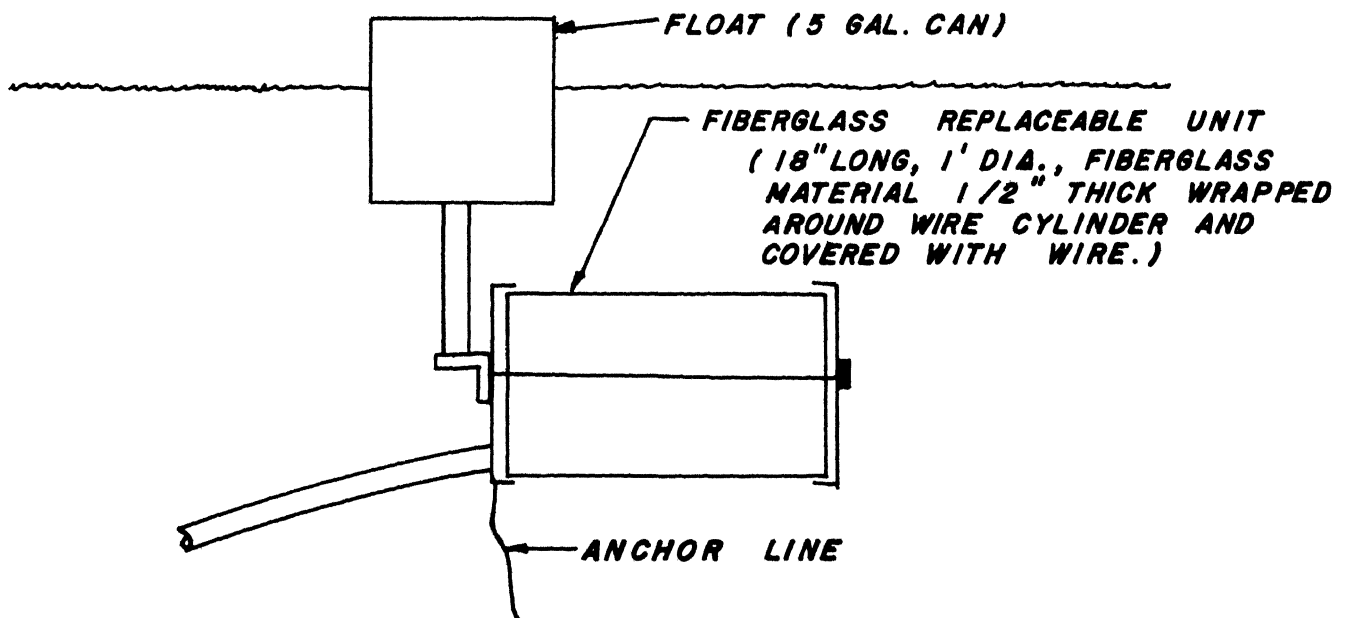
**FIGURE 23. EXPERIMENTAL FIBERGLASS SURFACE INTAKE  
INSTALLATION NO. 90**

The poor quality of water obtained from the pond in the spring of 1959 prodded the owner into replacing the buried-pipe intake with a surface type. An experimental surface intake was designed and placed in use in September 1959 (Fig. 23). The performance of this intake decreased with time. The fiber glass filter unit was not changed after the intake was placed in use. Apparently sediment built up on the fiber glass and in time pulled into the distribution system. During the winter months
